Can Manufacturer Increases Production, Improves Quality and Reduces Scrap

Case Study No. 186A ©Spraying Systems Co. 2014

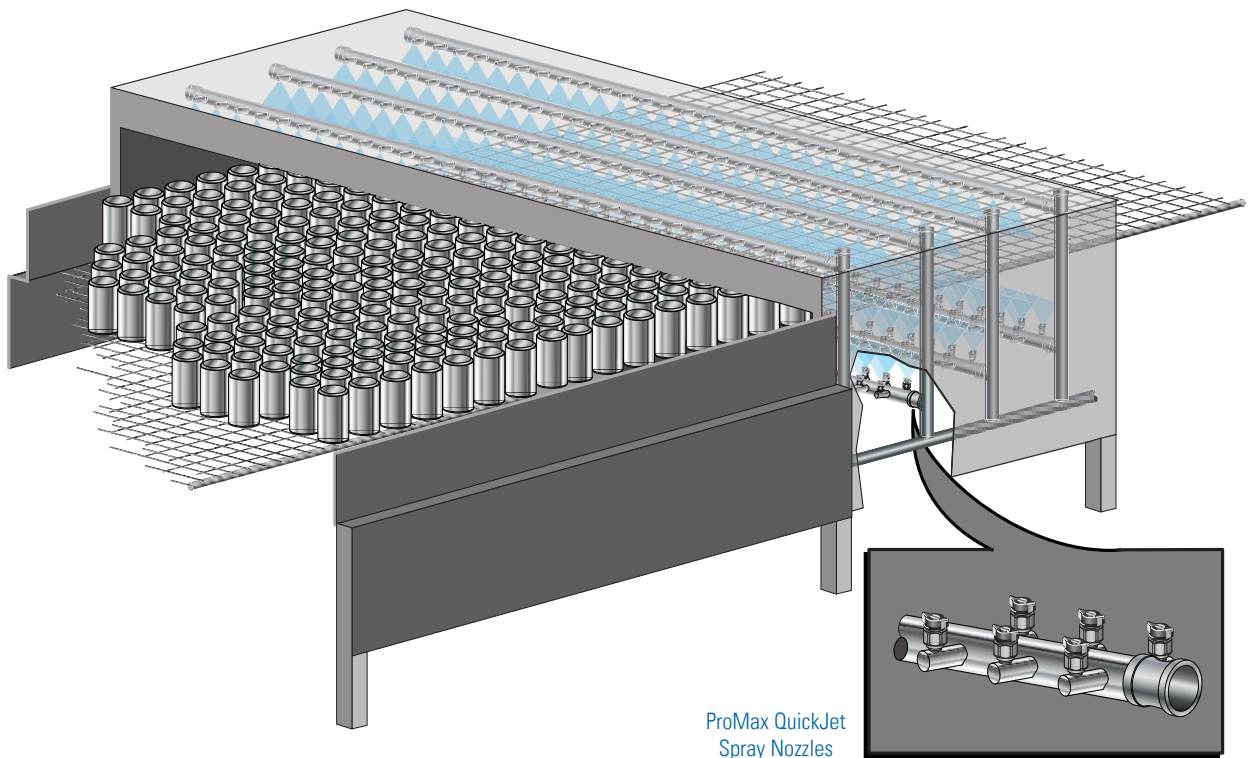
The Spraying Systems Co. solution features special headers spraying from above and below the conveyor to ensure the cans are washed thoroughly.

The new headers are each equipped with 40 ProMax® QuickJet® spray nozzles. The quick-connect nozzles provide the same flow rates as those used previously but have a narrower spray angle, larger orifice and lower operating pressure. Larger drops are produced, improving wettability and increasing impingement on hard-to-reach areas of the cans. The nozzles also feature an internal steel washer for extra strength.

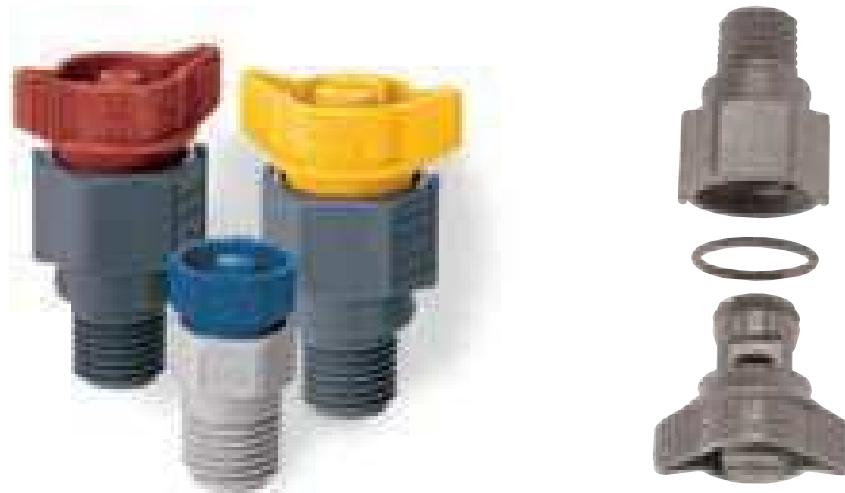
A CLOSER LOOK AT THE SYSTEM

ProMax® QuickJet® nozzles feature a quick-connect design that decreases maintenance time and reduces costs. The nozzle body stays on the header and only the spray tips are replaced. Spray tips are removed and installed by hand and spray patterns are automatically aligned.
